Invention Title: **Improved pump impeller**

## IMPROVED PUMP IMPELLER

10       The present invention relates to impellers and more particularly to impellers  
suitable for use in centrifugal pumps.

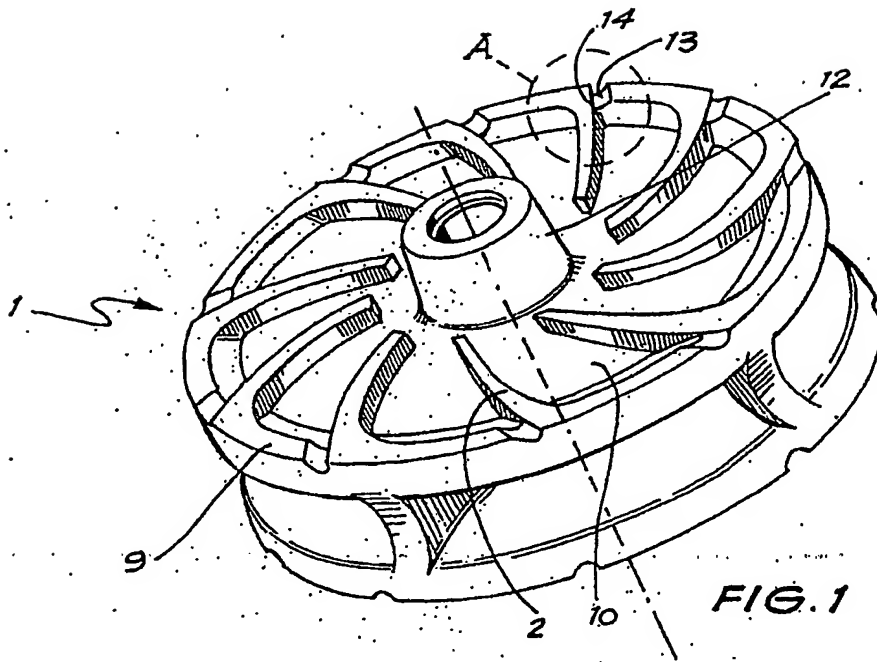
Figure 1 is a perspective view of a prior art impeller as shown by Figure 1 of United States Patent No. 4,664,592;

The prior art impeller 1 of Figure 1 is fully described in US 4,664,592 and it will be understood by reference to that specification.

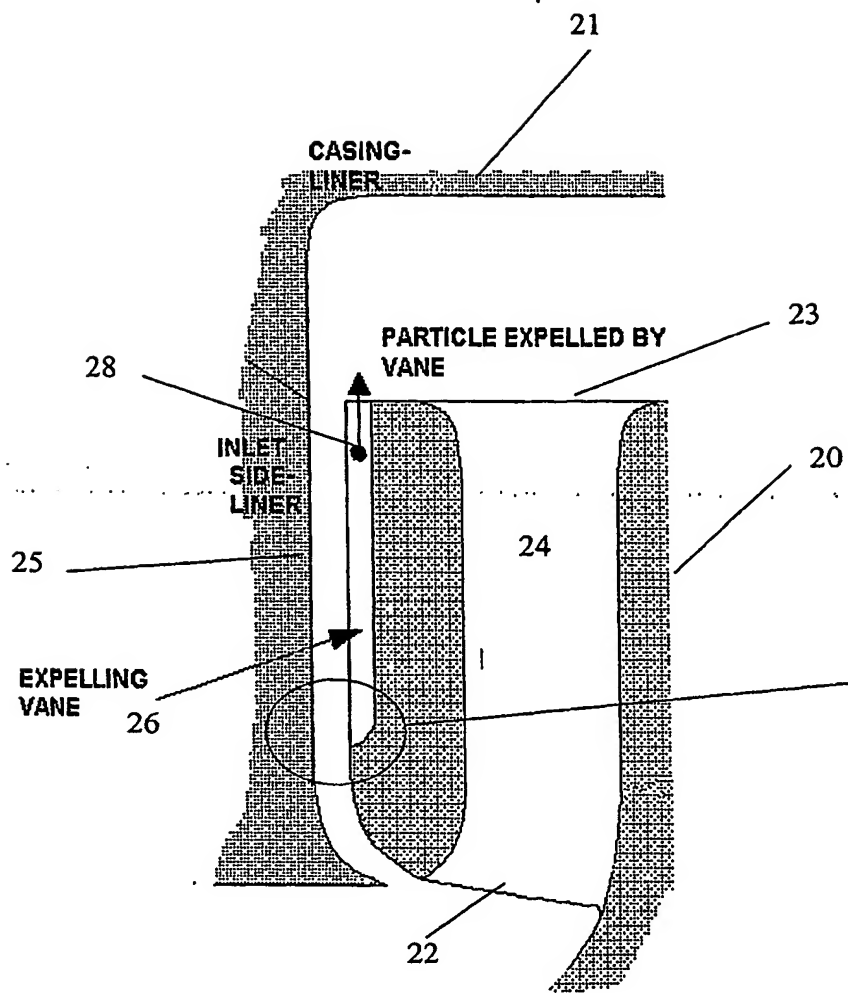
FIGURE 2

25 Figure 2 is a partial sectional view of a conventional impeller and expeller or auxiliary vane of a centrifugal pump;

As shown in Figure 2 an impeller 20 is housed in casing liner 21. Slurry travels through impeller 20 from inlet 22 to outlet 23 of each pumping chamber 24 as the impeller rotates within casing liner 21. A recirculating flow of slurry from outlet 23 to inlet 22 occurs naturally and causes abrasive wear of the inlet side liner 25. Expelling or auxiliary  
25 vane 26 acts to move the recirculating slurry 27 back toward the impeller outlet as represented by particles 28. The slurry flow path between impeller 20 and liner 25 is shown in more detail by Figure 3.

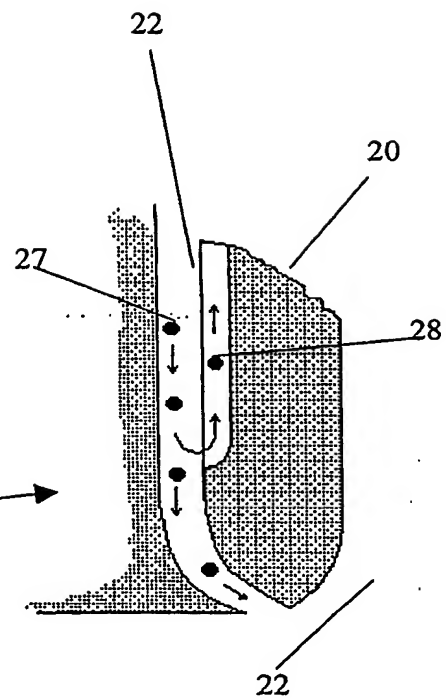
FIGURE 3

Figure 3 is a magnification of the circled portion of Figure 2 showing the slurry flow paths between a auxiliary vane and casing liner;

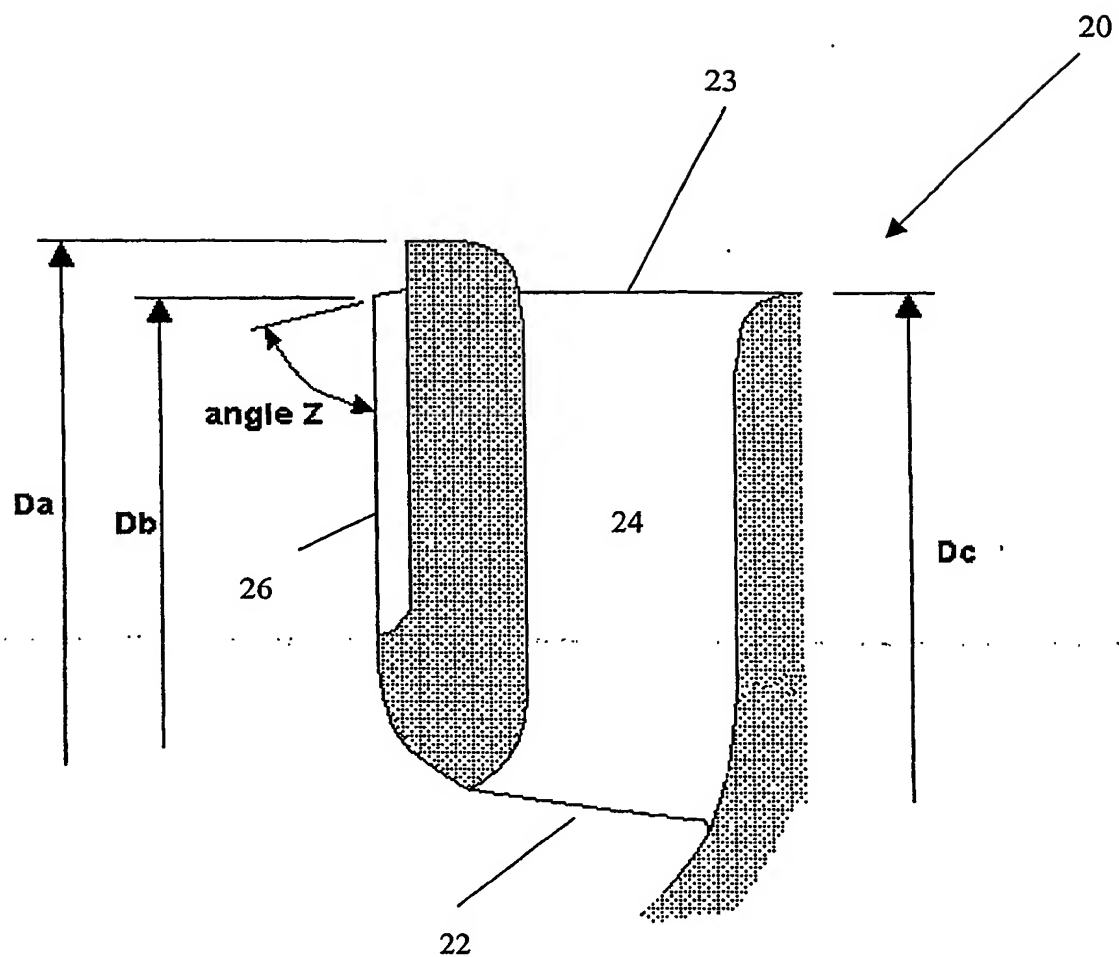
**FIGURE 5**

Figures 5 is a part sectional view similar to Figure 2 but showing an embodiment of an impeller in accordance with the present invention;

Figure 5 includes the same reference numerals for like parts as those designated in Figures 2 and 3. In this embodiment of the present invention the auxiliary vanes are straight, with a diameter to the point shown on auxiliary vane 26 of  $Db=0.85Da$ , wherein  
 5 Da is the shroud diameter, and where angle  $Z=45^\circ$ . The diameter of Db is approximately equal to the diameter of main pumping vane denoted as Dc in Figure 5.

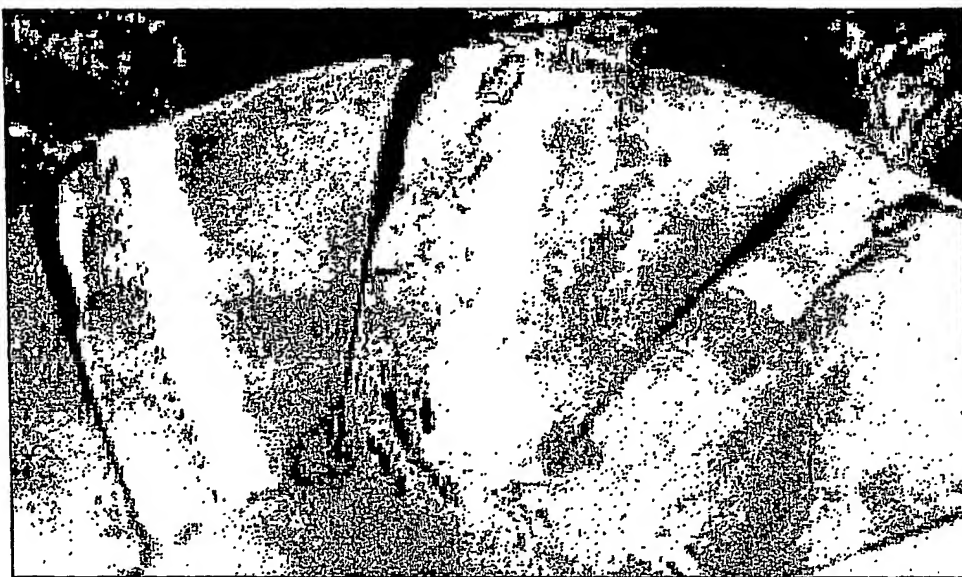
FIGURE 6

Figure 6 is a photograph showing the wear profile of auxiliary vanes of a prior art  
5 impeller;

As can be seen in the photograph of Figure 6, the wear on the auxiliary vanes of these known impeller is extensive.

20 The impeller embodiment 30 of Figure 8 is formed with auxiliary vanes 31 having curved leading and trailing edges instead of straight as for the embodiments of Figures 5 and 7. The corresponding prior art arrangement is shown in Figure 6. Again, this embodiment of the present invention shows much reduced wear at the vane tips when compared with its prior art equivalent for similar operating times.

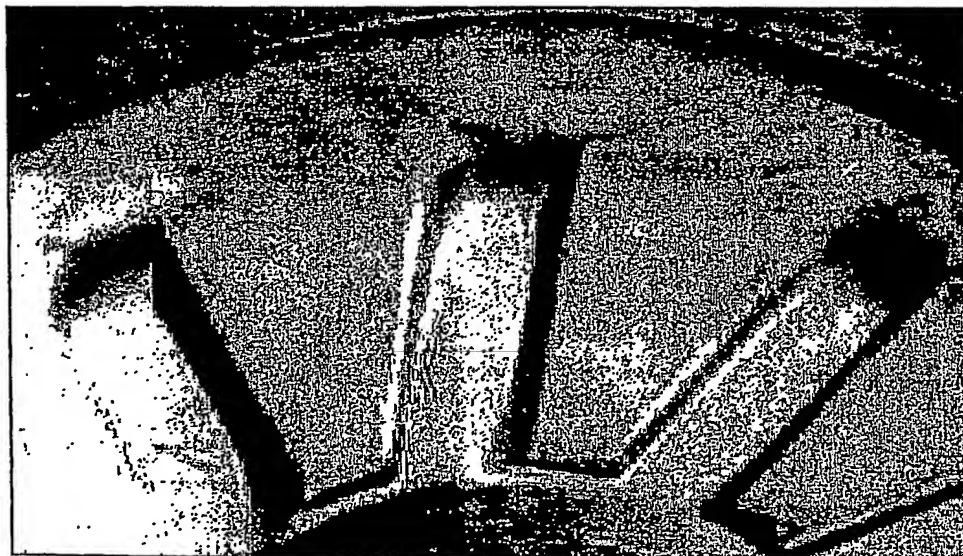
FIGURE 7

Figure 7 is a photograph showing the wear profile of auxiliary vanes on an impeller in accordance with an embodiment of the present invention;

15 By contrast, the auxiliary vanes on the impeller of Figure 7 are in considerably better condition than those shown in Figure 6, despite having been under operation in a similar environment and for a similar period of time.

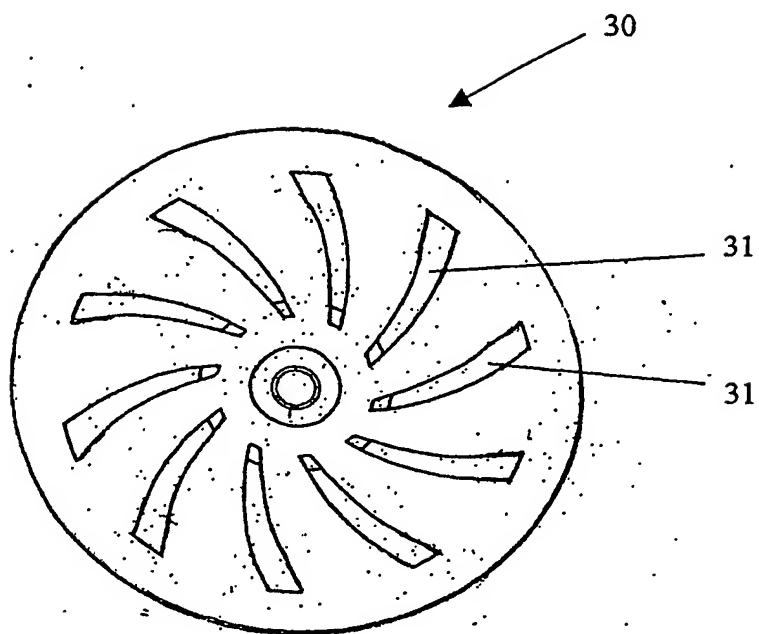
**FIGURE 8**

10 Figure 8 is an axial or end view of a further embodiment of an impeller in accordance with the present invention; and

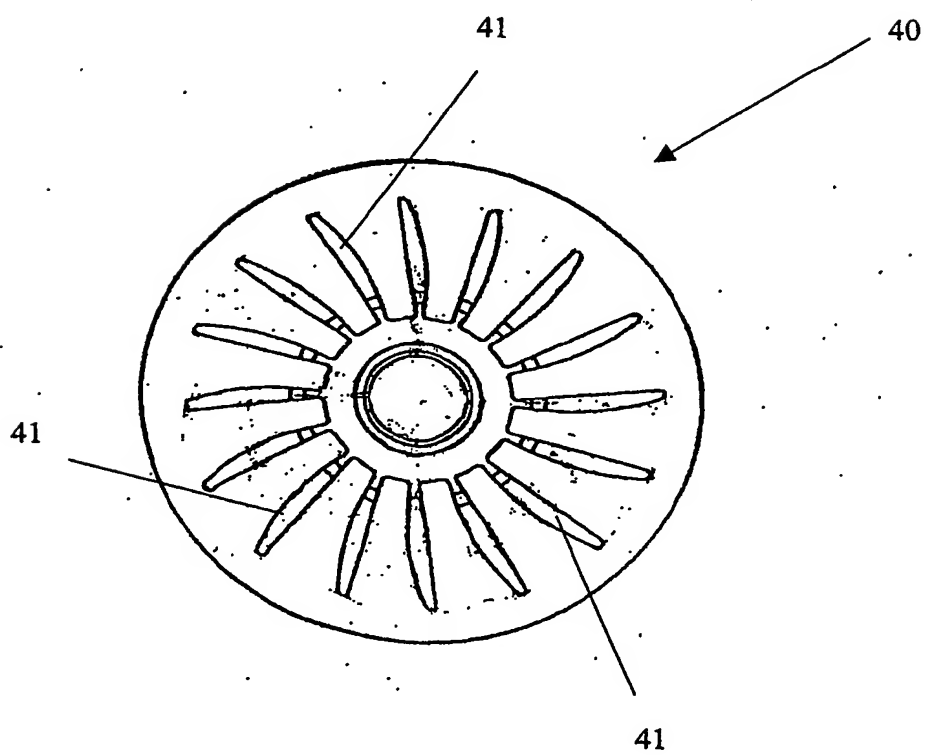
**FIGURE 9**

Figure 9 is an axial or end view of yet another embodiment of an impeller in accordance with the present invention.

25 The embodiment of Figure 9 shows yet another variation of profile for the auxiliary vanes 41 of the impeller 40.
